# IVUS Imaging Collections

**Intravascular Ultrasound**

**Shigeru Nakamura M.D. / Tadahisa Okada C.E. / Tomoko Tachi C.E.**  
**Kyoto Katsura Hospital, Japan**

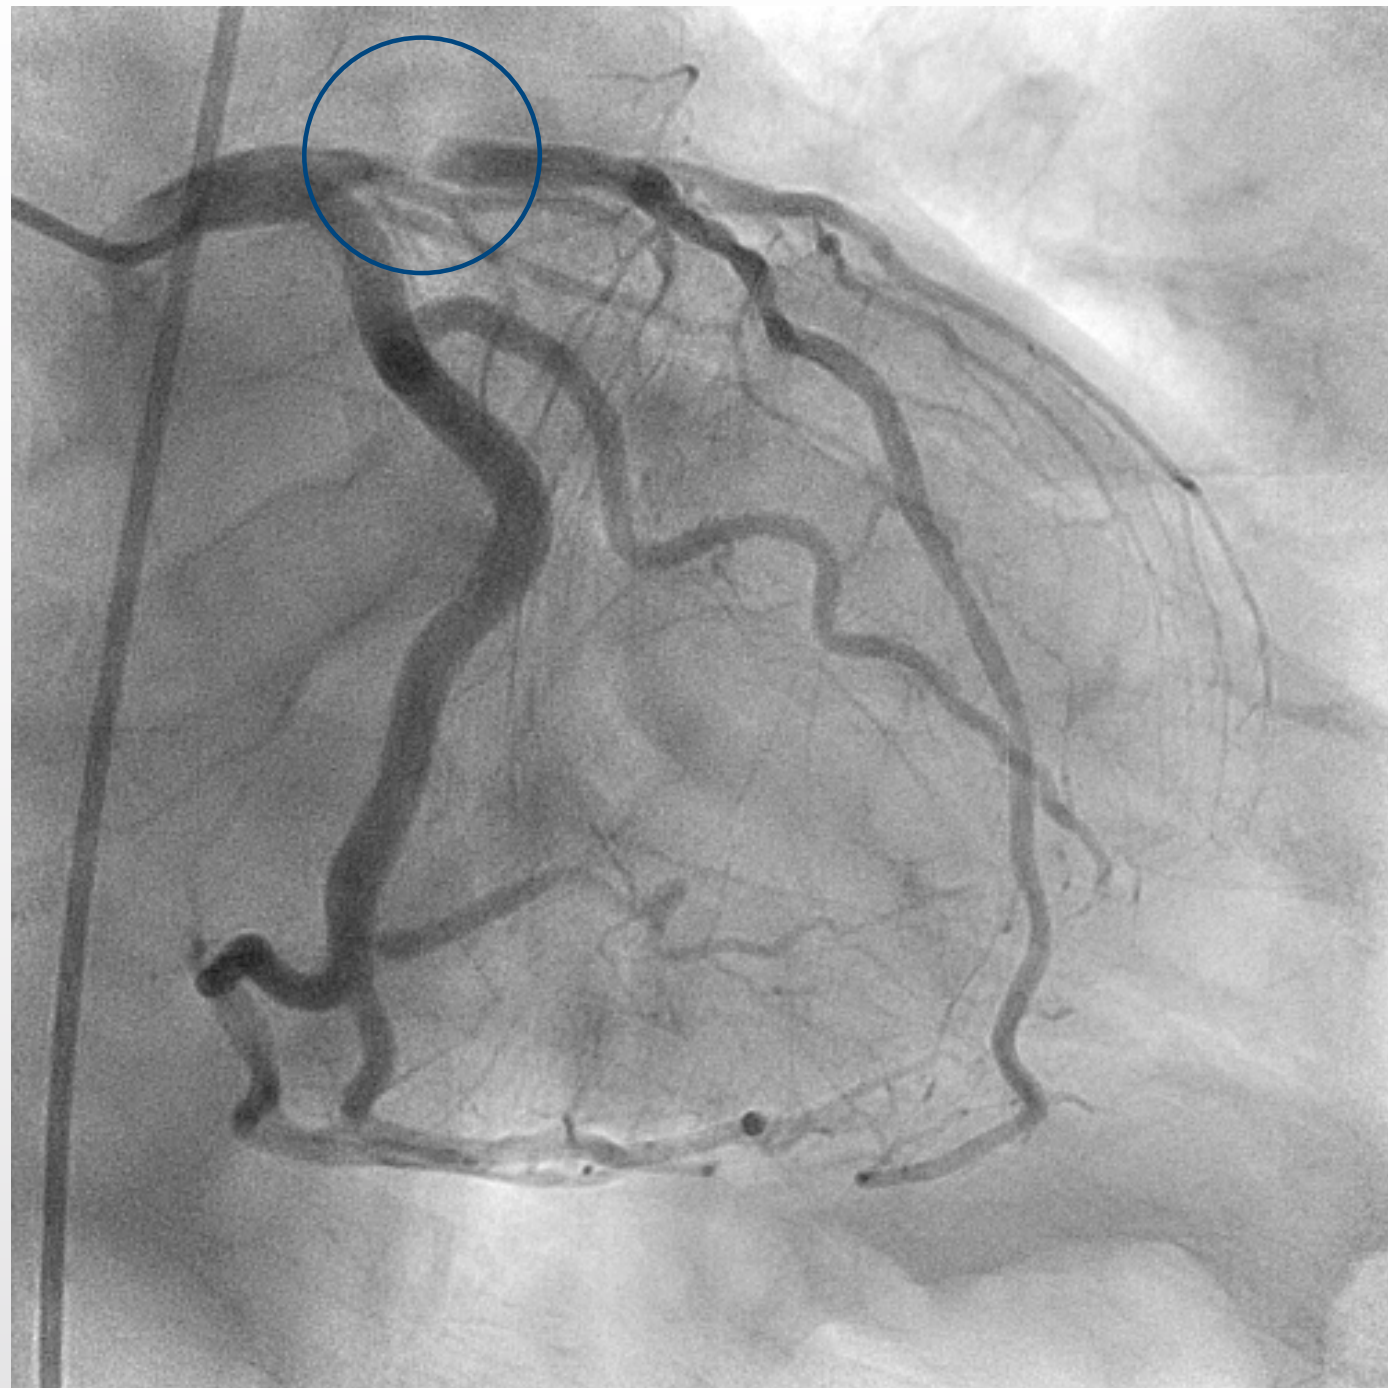
# 3 Lipid Plaque

The IVUS image is rotated to position the epicardium at 12 o'clock. The stenosis is located at the proximal LAD with RAO caudal view by angiogram. On the IVUS image, a hypoechoic area is observed from 9 to 12 o'clock, which looks dark (attenuated echo). The area is considered as a lipid pool and presumed to be lipid rich. A lipid pool can be mistaken as a thrombus, and it is sometimes difficult to distinguish them.

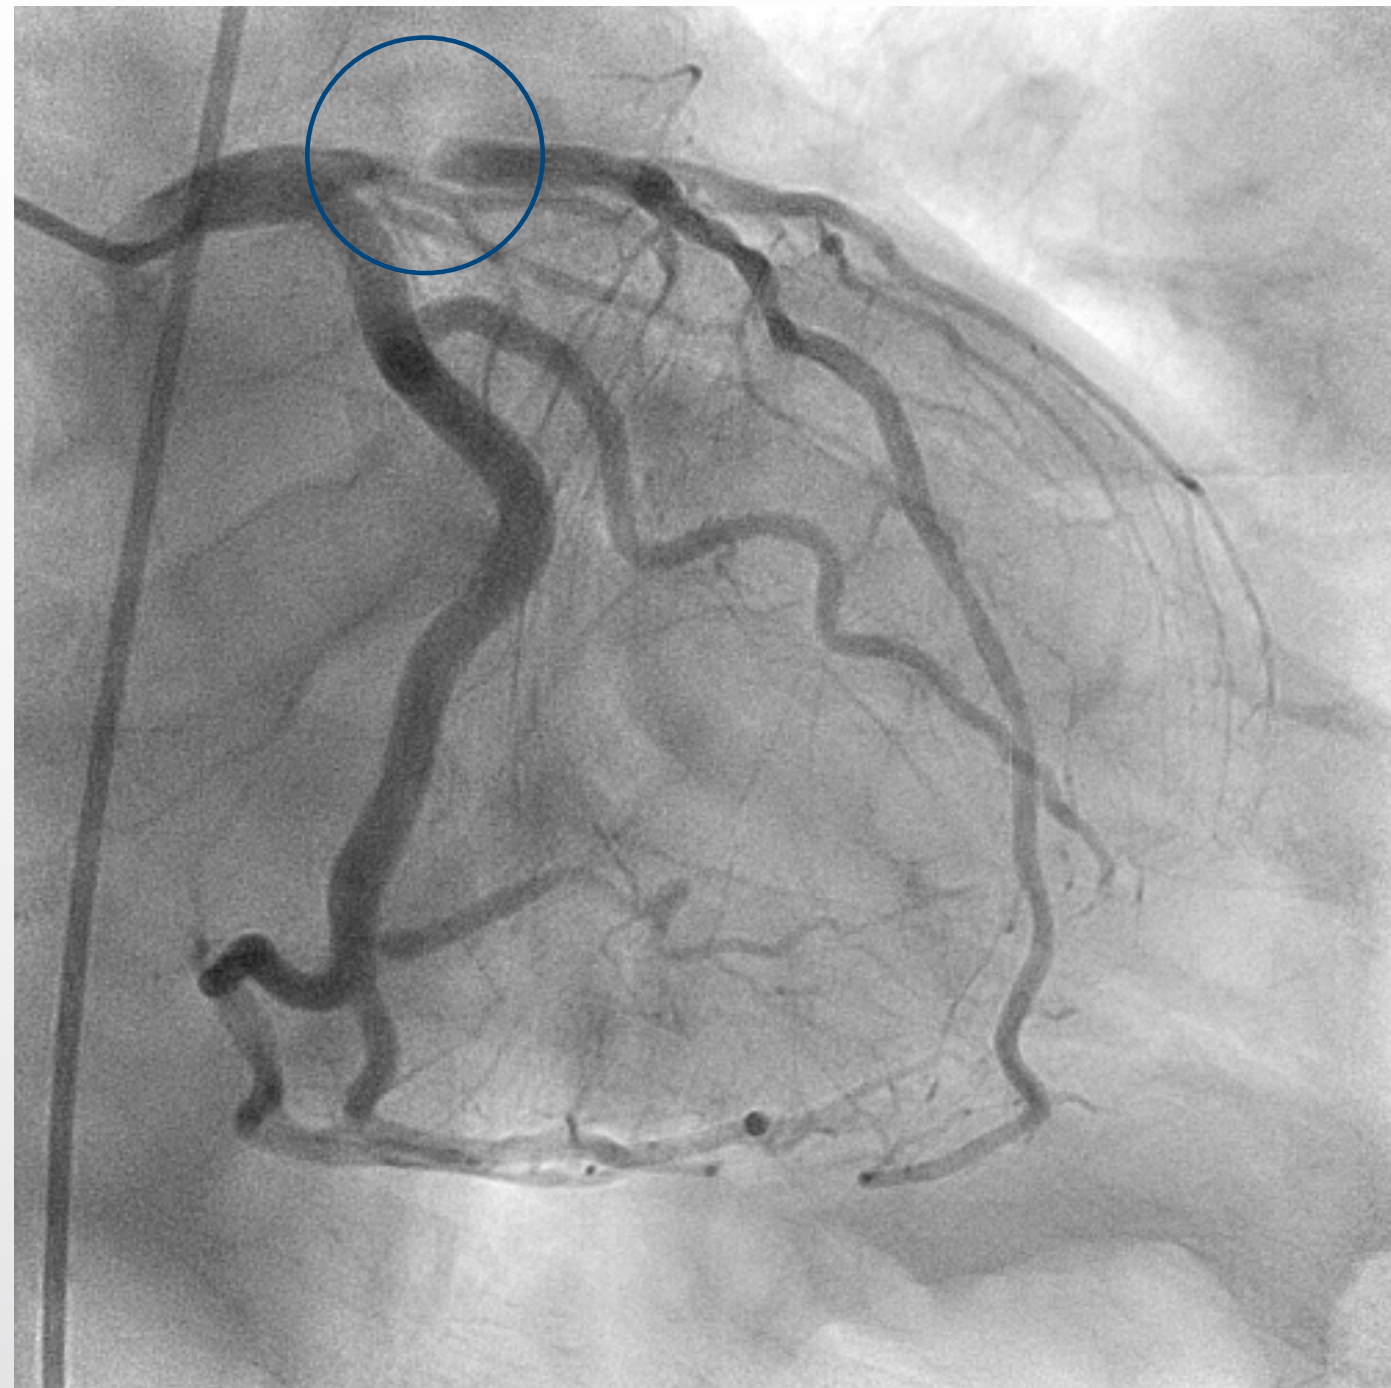
# 3 Lipid Plaque

The IVUS image is rotated to position the epicardium at 12 o'clock. The stenosis is located at the proximal LAD with RAO caudal view by angiogram. On the IVUS image, a hypoechoic area is observed from 9 to 12 o'clock, which looks dark (attenuated echo). The area is considered as a lipid pool and presumed to be lipid rich. A lipid pool can be mistaken as a thrombus, and it is sometimes difficult to distinguish them.

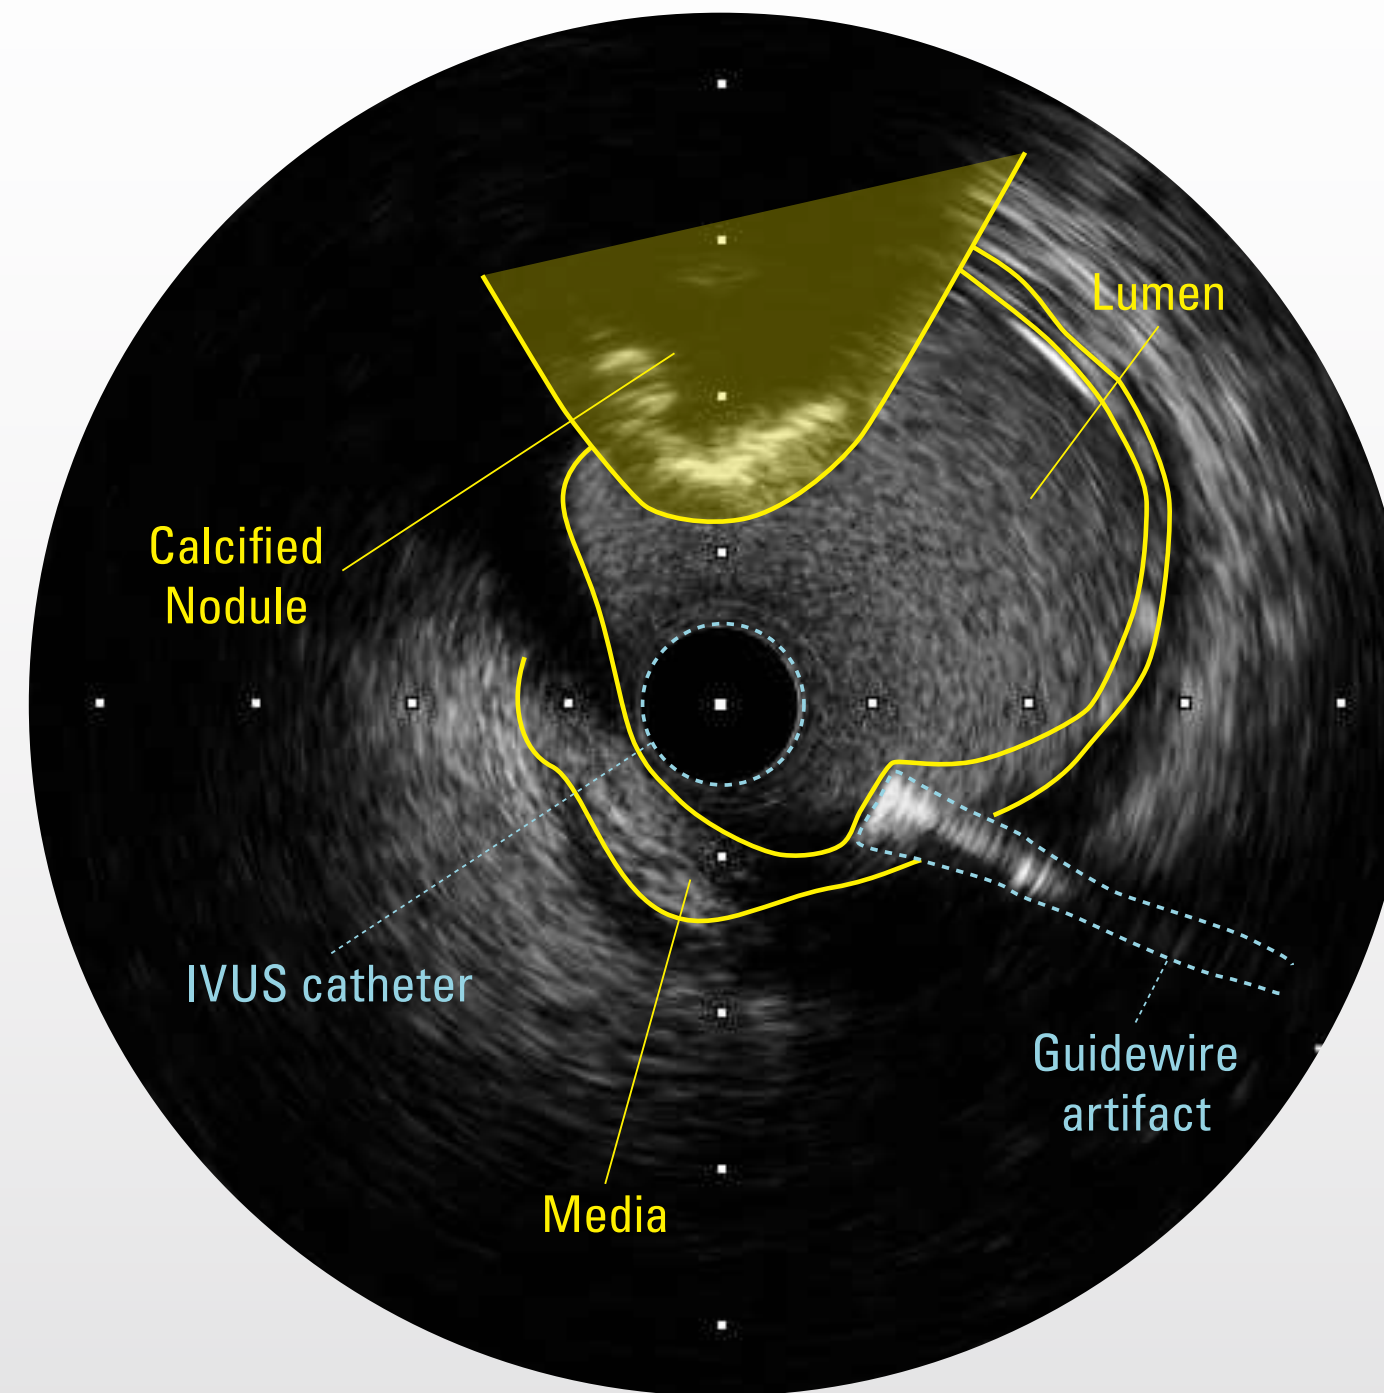
# 6 Calcified Nodule

A distorted hyperechoic area is observed with an acoustic shadow protruding at the 12 o'clock position in the left main trunk (LMT). It is found to be protruding into the lumen and is thus considered to be a calcified nodule. Calcified nodules have irregular surface and sometimes have coral-like shape. On the IVUS image, the LMT is not significantly stenosed.

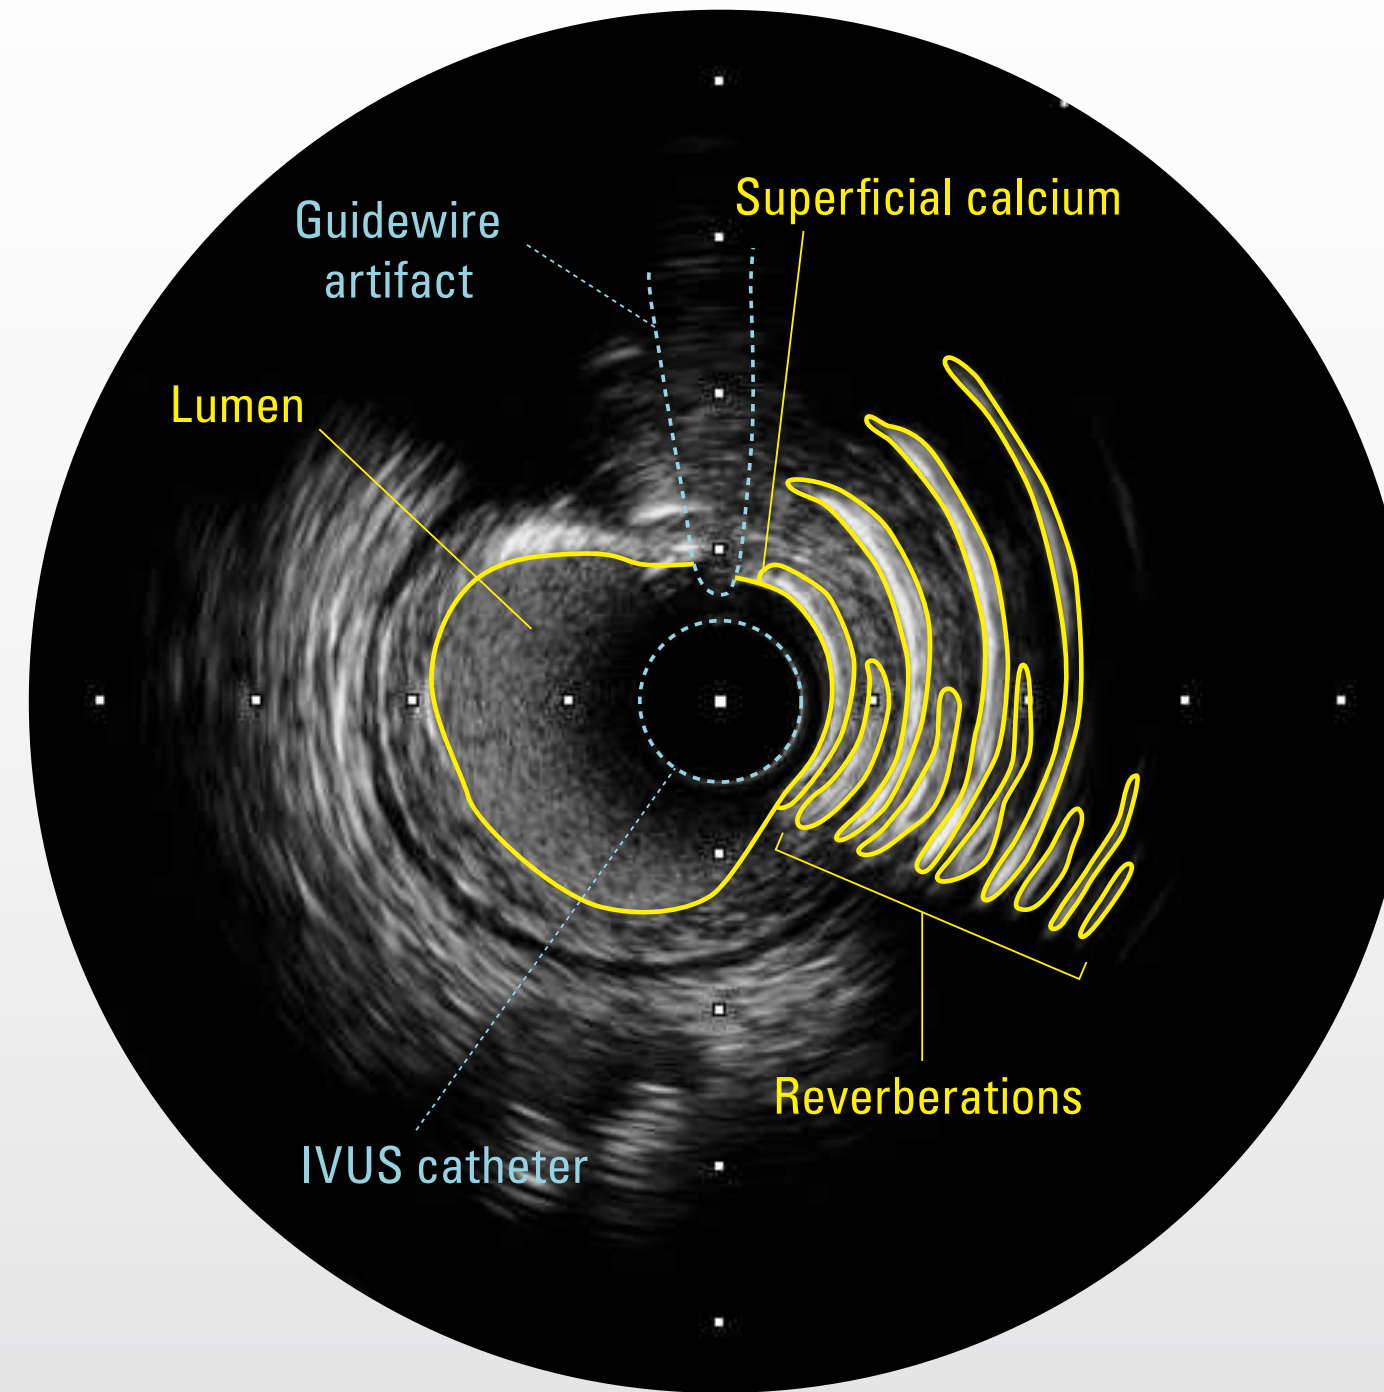
# 7 Reverberation

Equally spaced hyperechoic arches, which are observed concentrically from 2 to 4 o'clock clockwise, are called reverberations of calcified plaque.

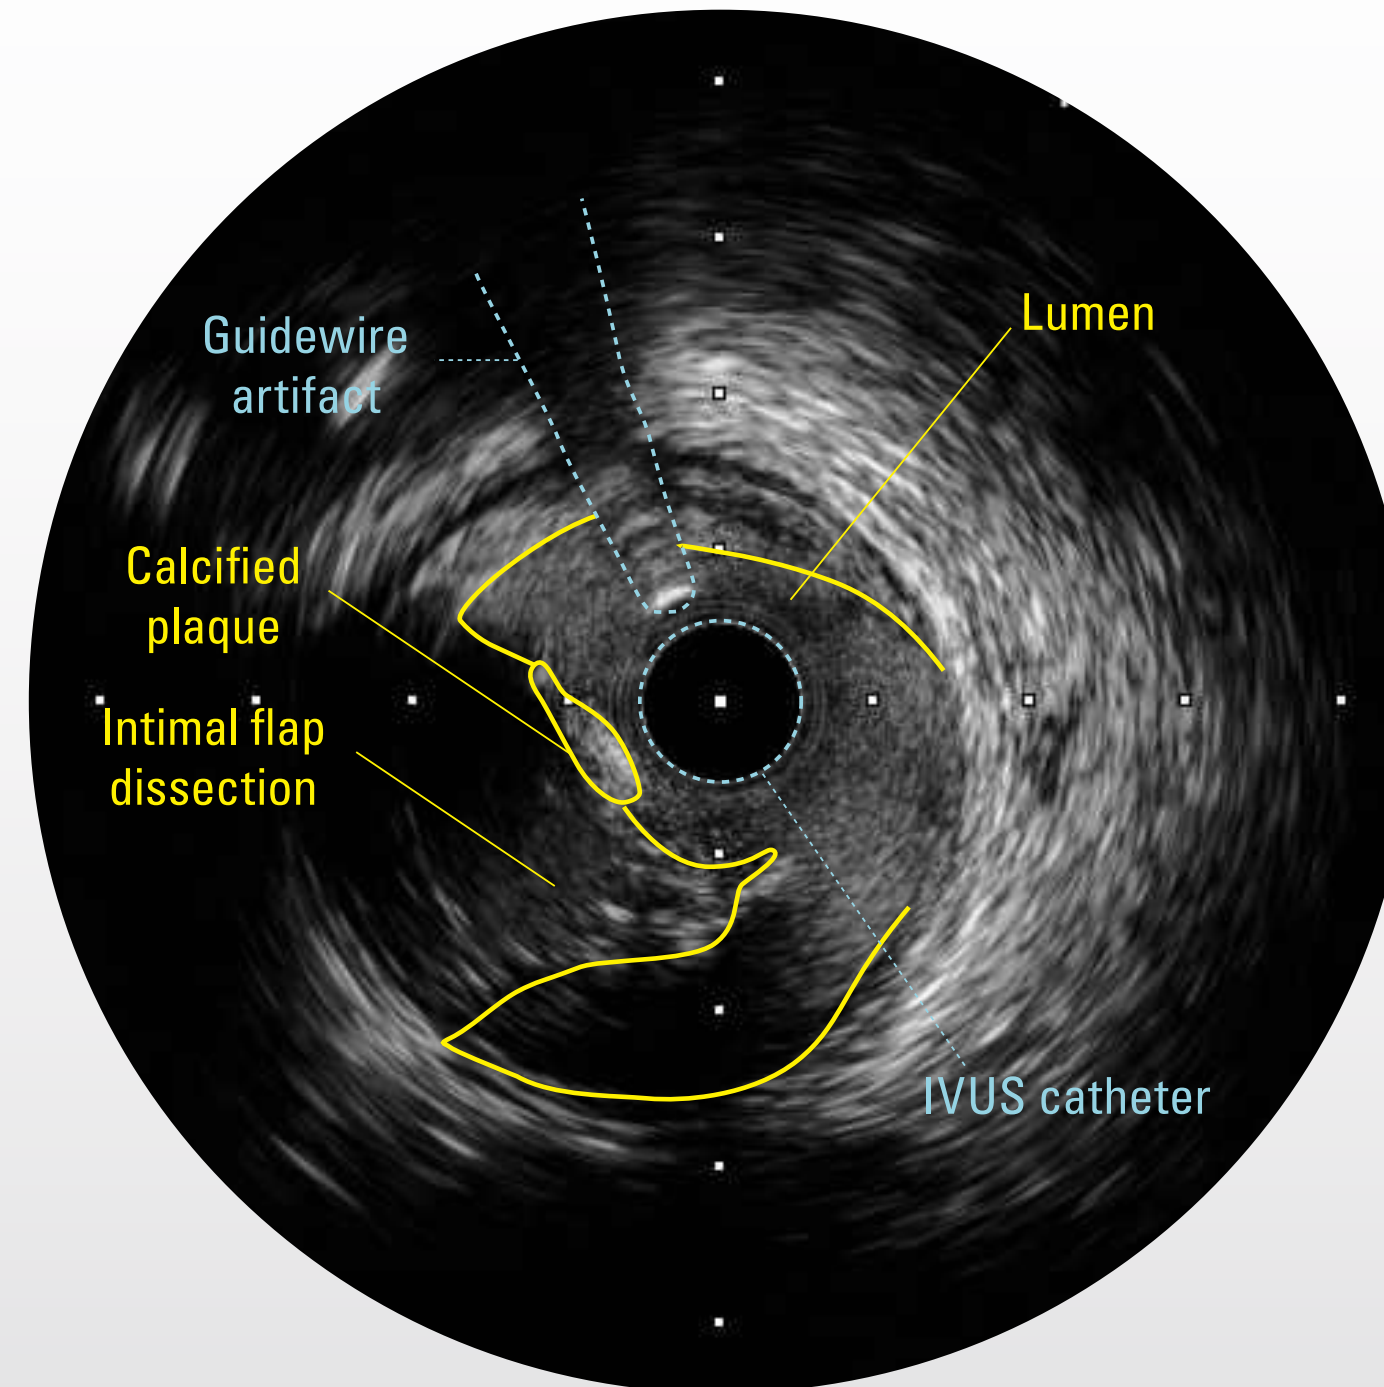
# 13 Plaque Dissection

An example of plaque dissection. Both the intima and the plaque are disrupted, and the disruption extends into the media. Where the ruptured end protrudes into the lumen and if it becomes thin and movable, it is called a flap.

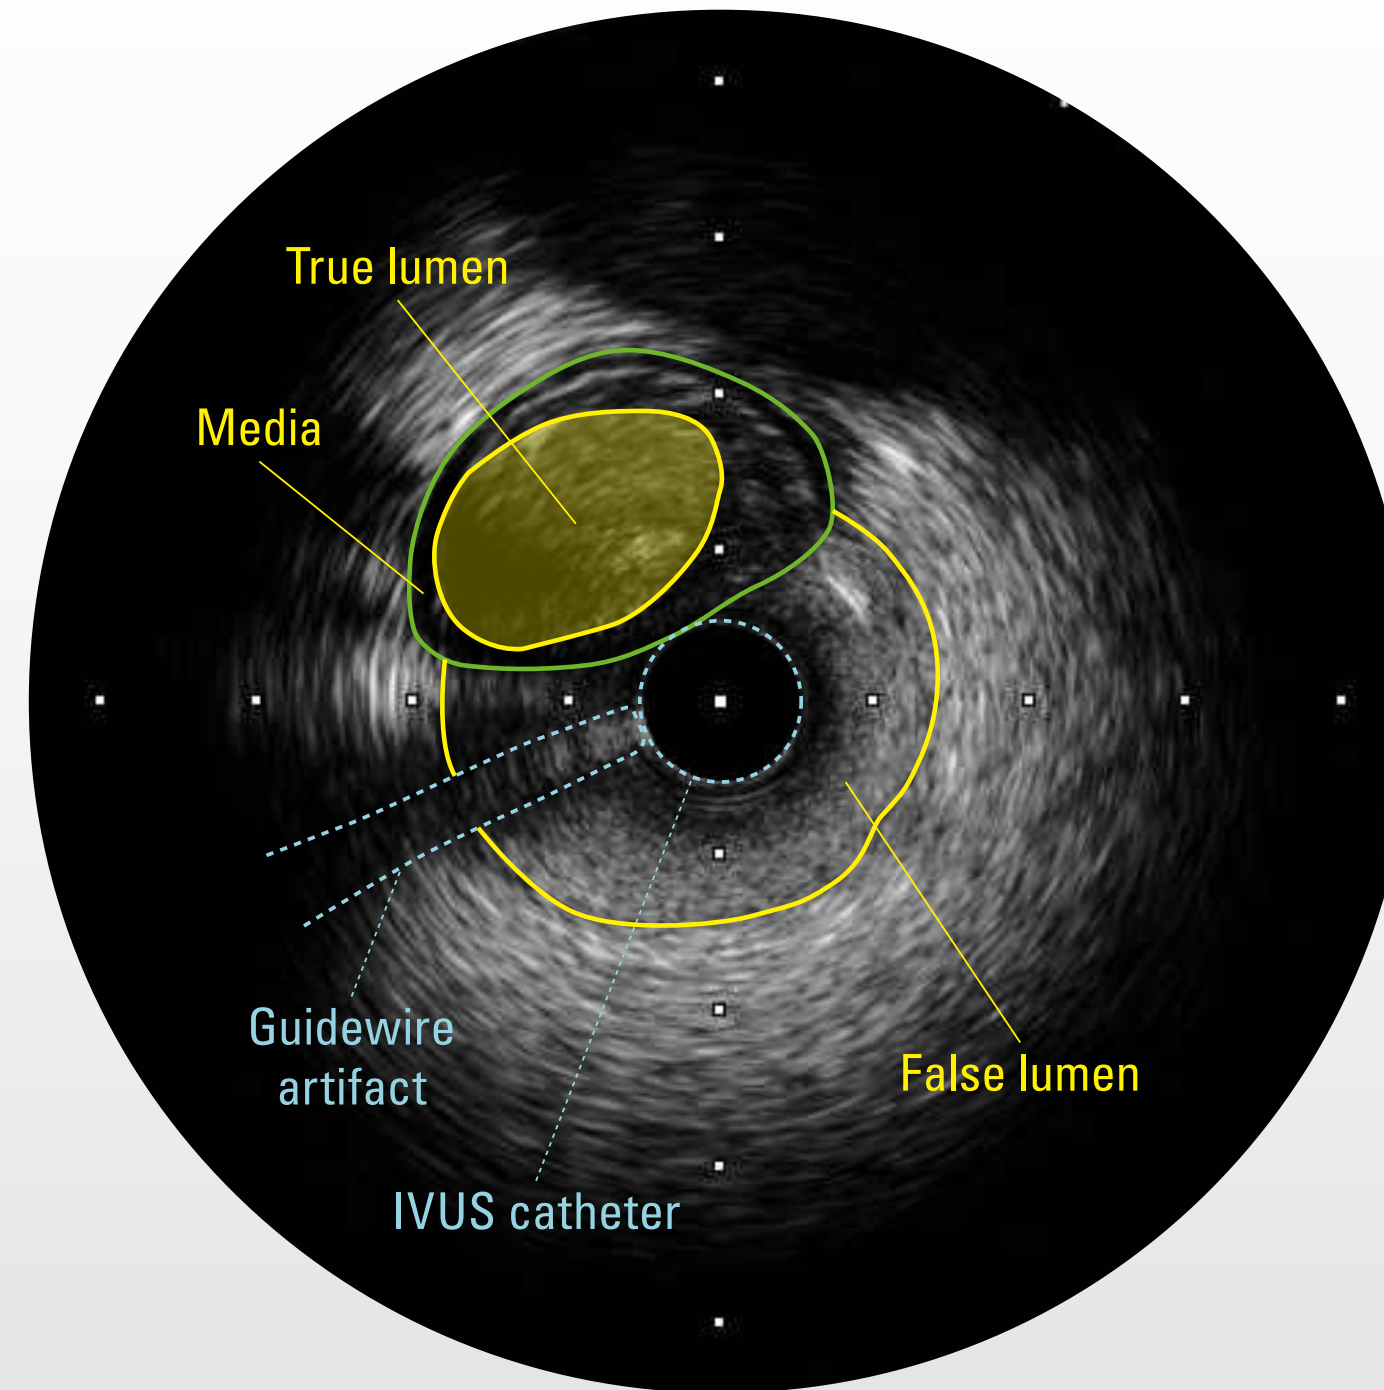
# 20 CTO - False Lumen

This image was taken during a case of CTO PCI using an antegrade dissection reentry (ADR) device. The IVUS catheter is inside the false lumen. The true lumen with the three-layered structure is observed at 11 o'clock. The false lumen is visualized by hyperechoic homogenous blood speckle due to the stagnant blood flow.

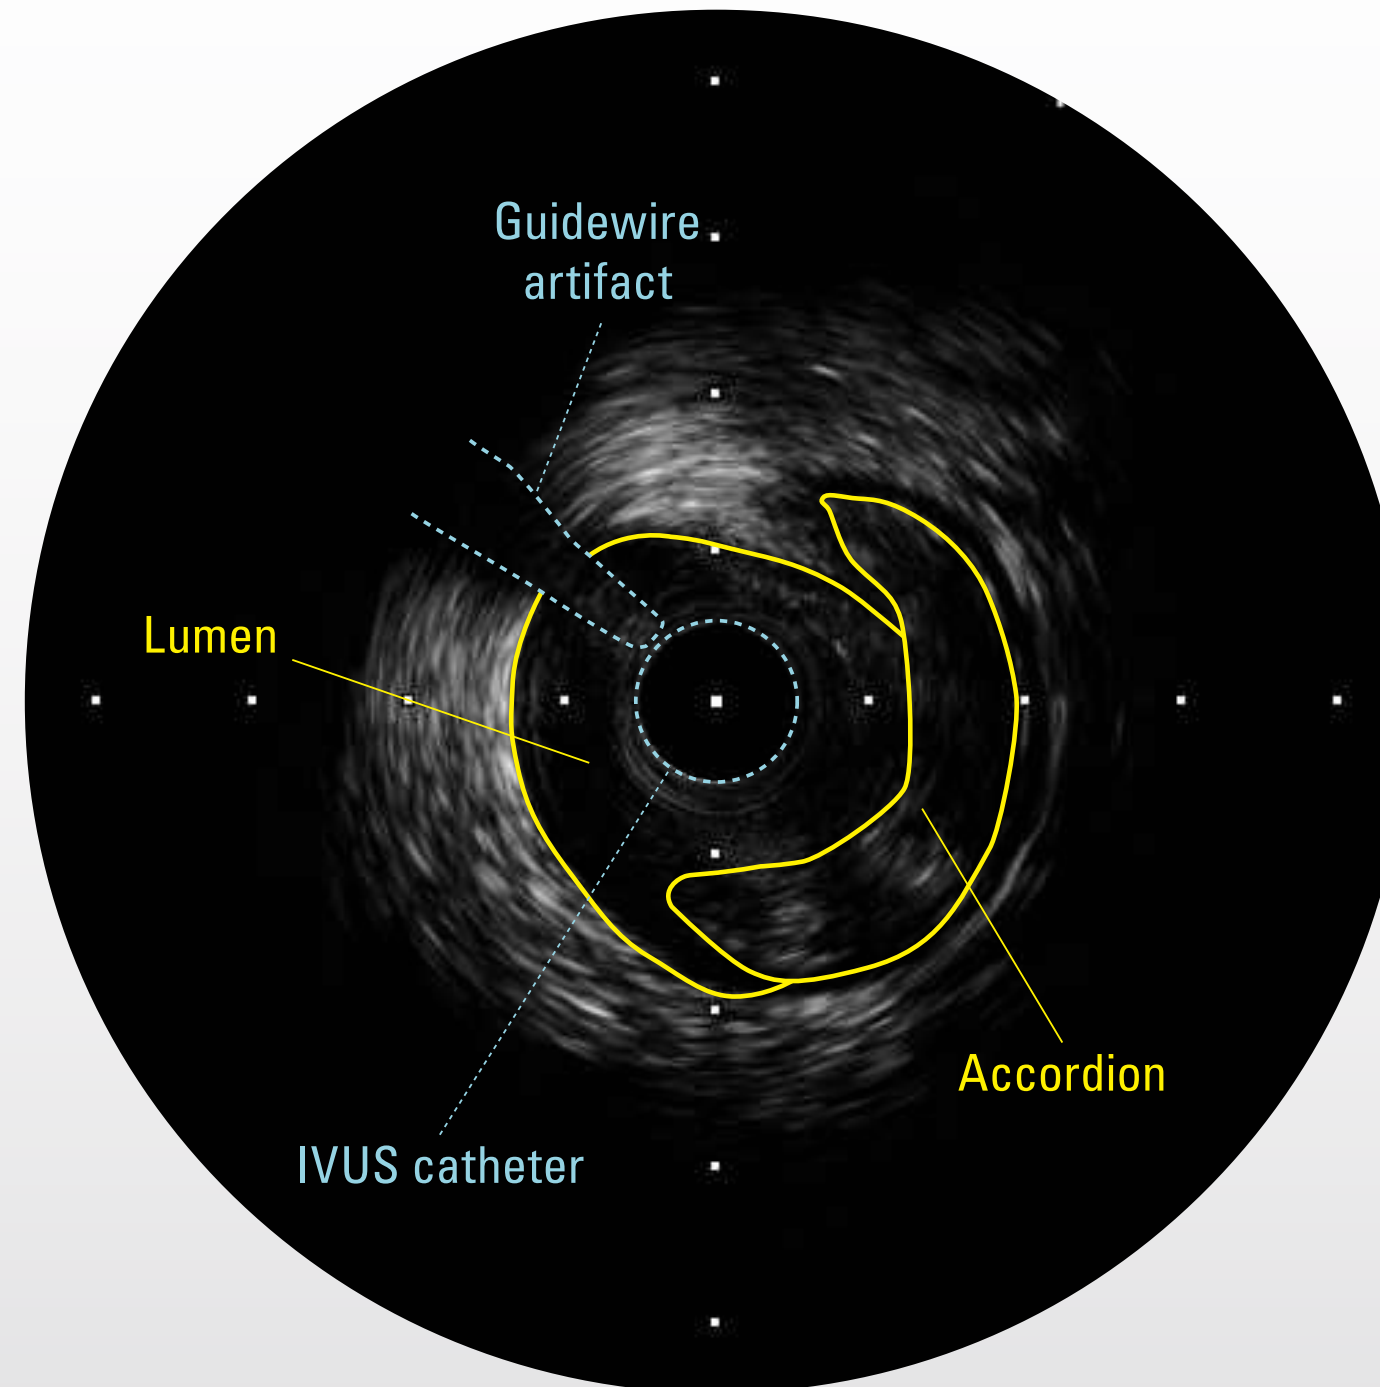
# 21 Accordion

A vague crescent-shaped vessel structure is observed from 1 to 7 o'clock. The media is observed near the IVUS catheter, but another media is depicted from 2 to 5 o'clock. This image was created due to the accordioned vessel as two vessel structures are observed in one image. The accordion is observed when an IVUS catheter straightens a tortuous vessel.

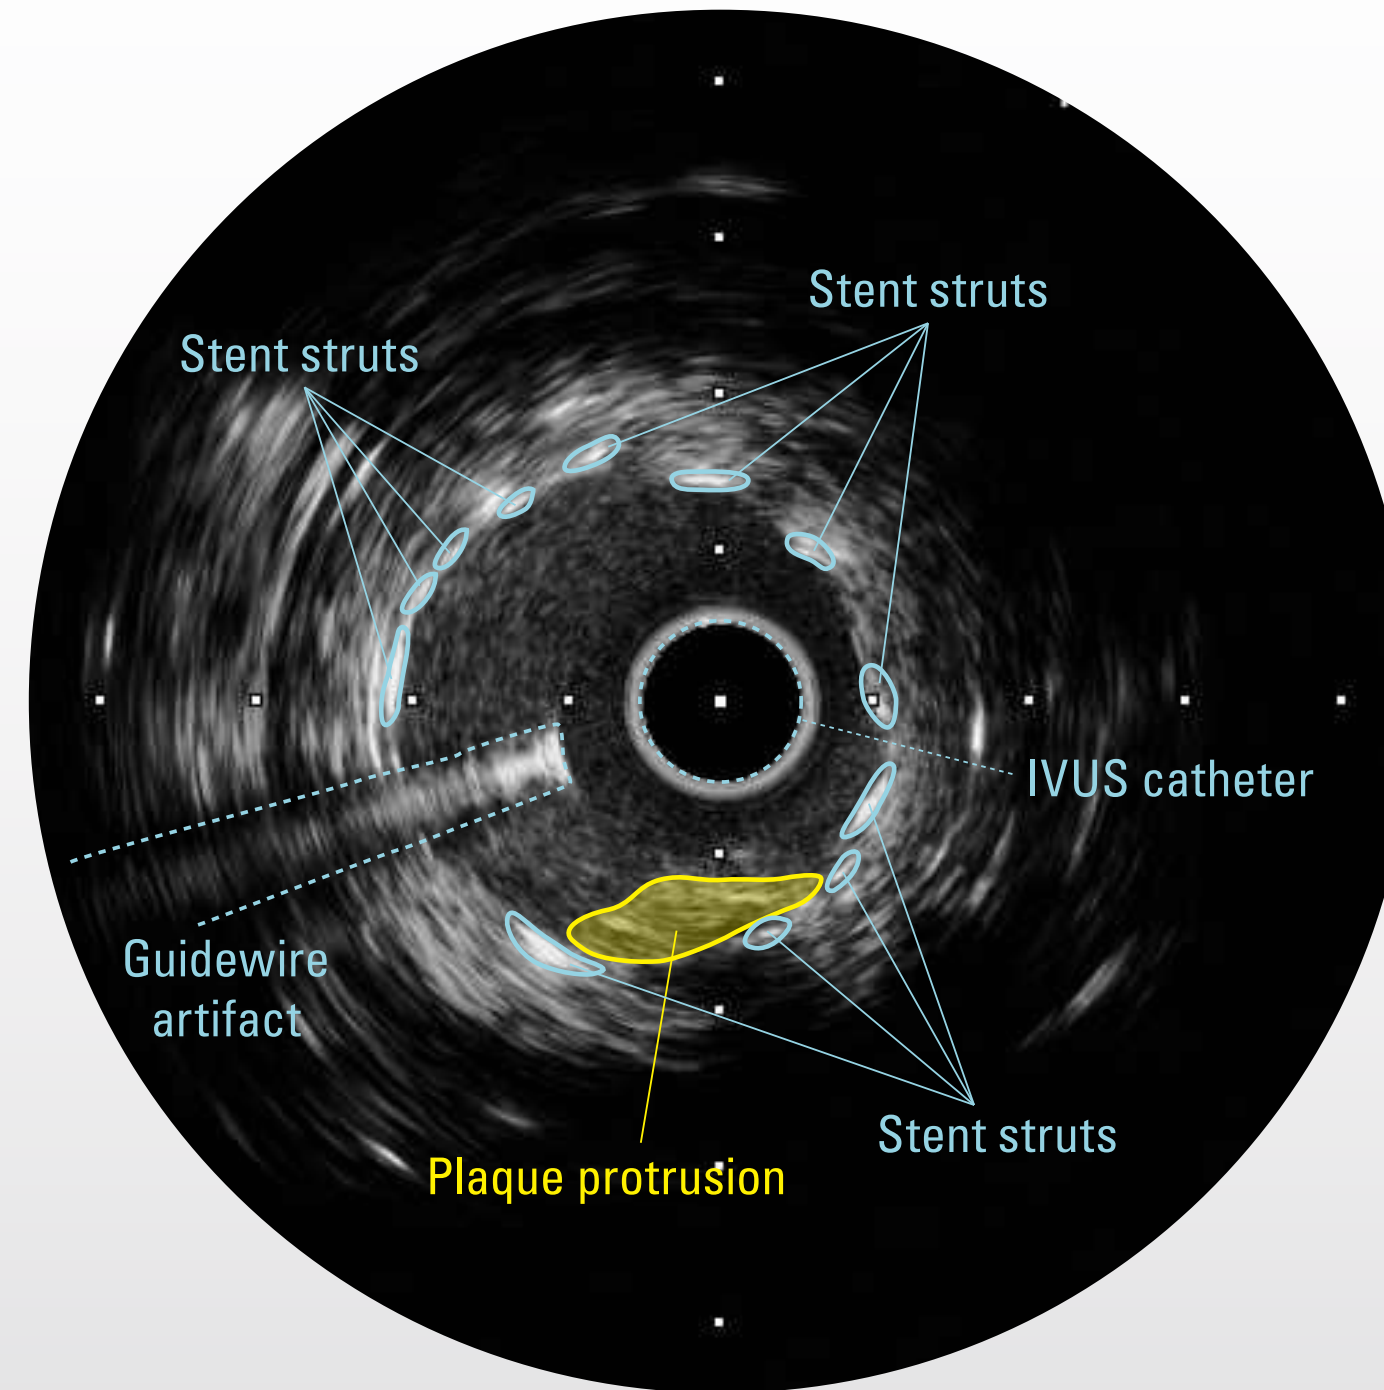
# 29 Plaque Protrusion

On stent implantation in an ACS case, some protrusions may be observed in between the stent struts.

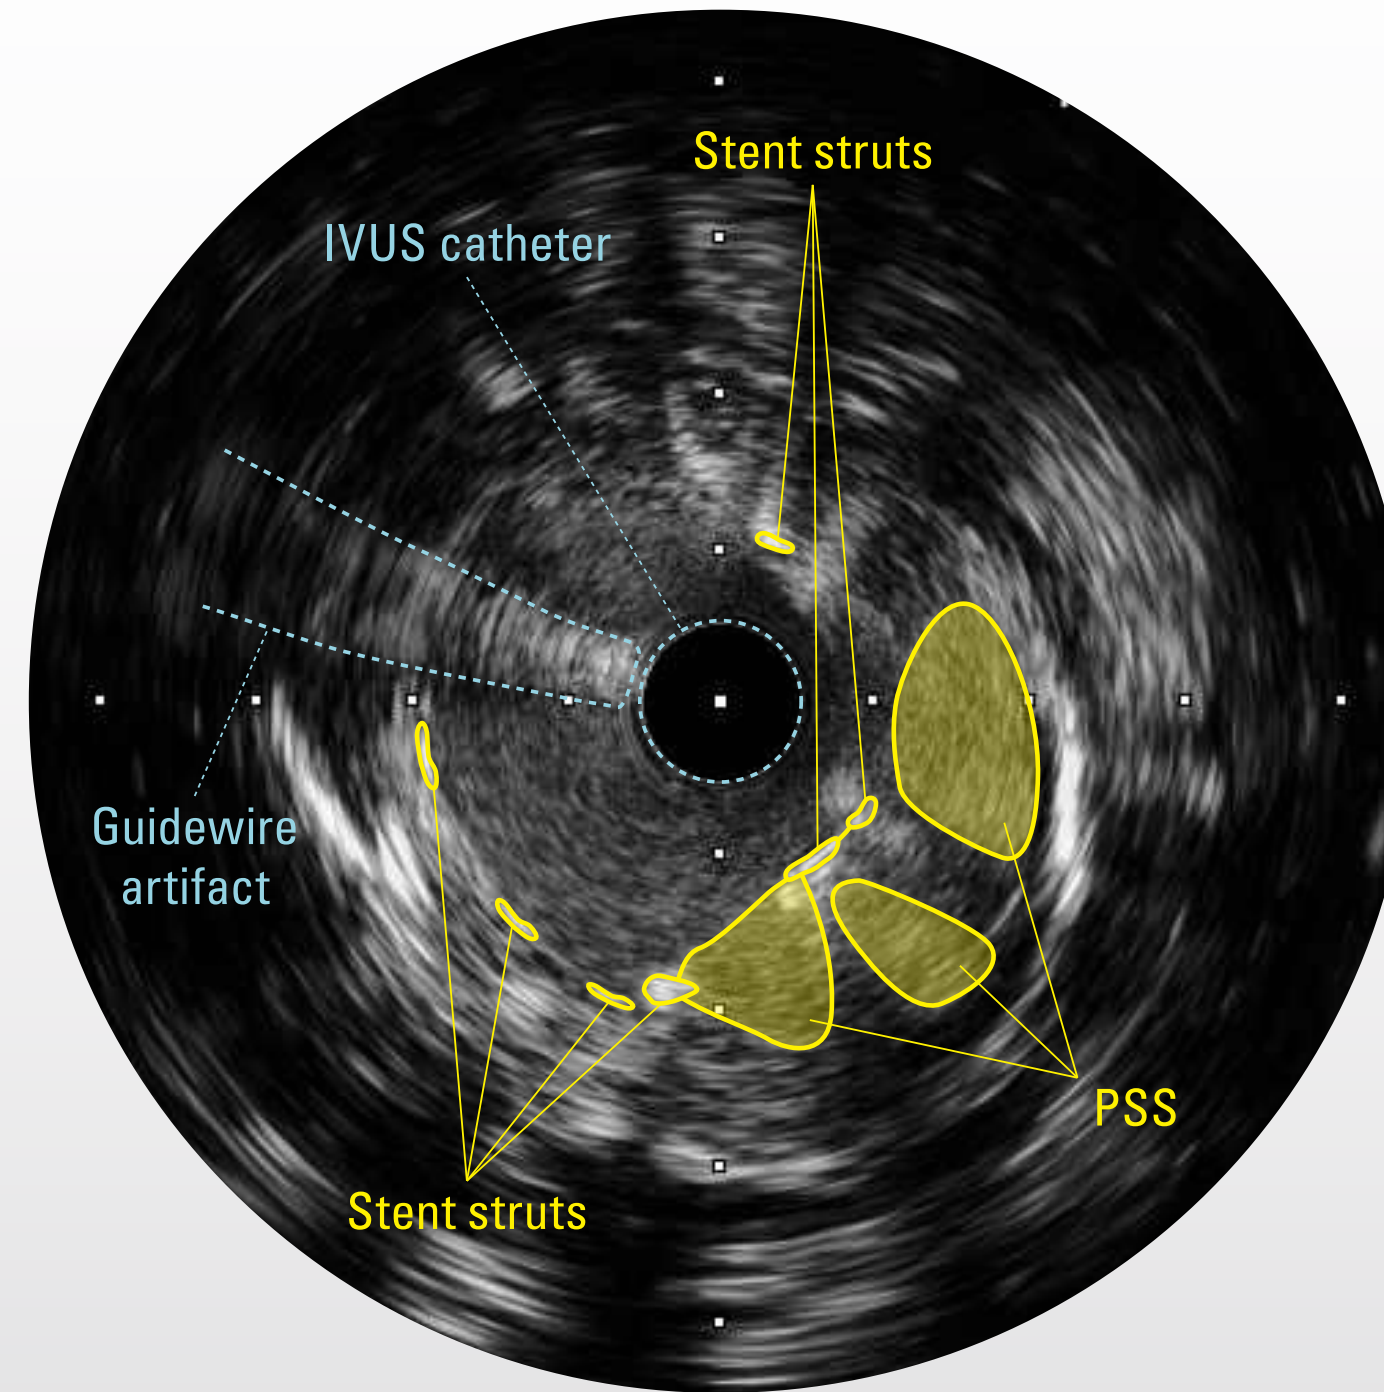
# 30 Peri-stent Contrast Staining

A sirolimus-eluting stent (SES) was implanted in the left anterior descending artery (LAD) fourteen years ago. The IVUS image shows that the stent struts do not contact the vessel wall from 1 to 7 o'clock and blood speckle is observed behind the struts. Meanwhile, the vessel size and diameter are enlarged to approximately 6 mm. Following angiogram shows peri-stent contrast staining (PSS). Contrast media is visualized behind the stent struts by angiogram.
